TNG-led Emergency Salmon Task Force Weekly Data Report July 01 – 07 2025

The following weekly report prepared by TNG with support from Ecofish, summarizes 2025 monitoring data for environmental conditions and fish passage from May 1 to July 8, 2025 (start date varies with program). This summary includes:

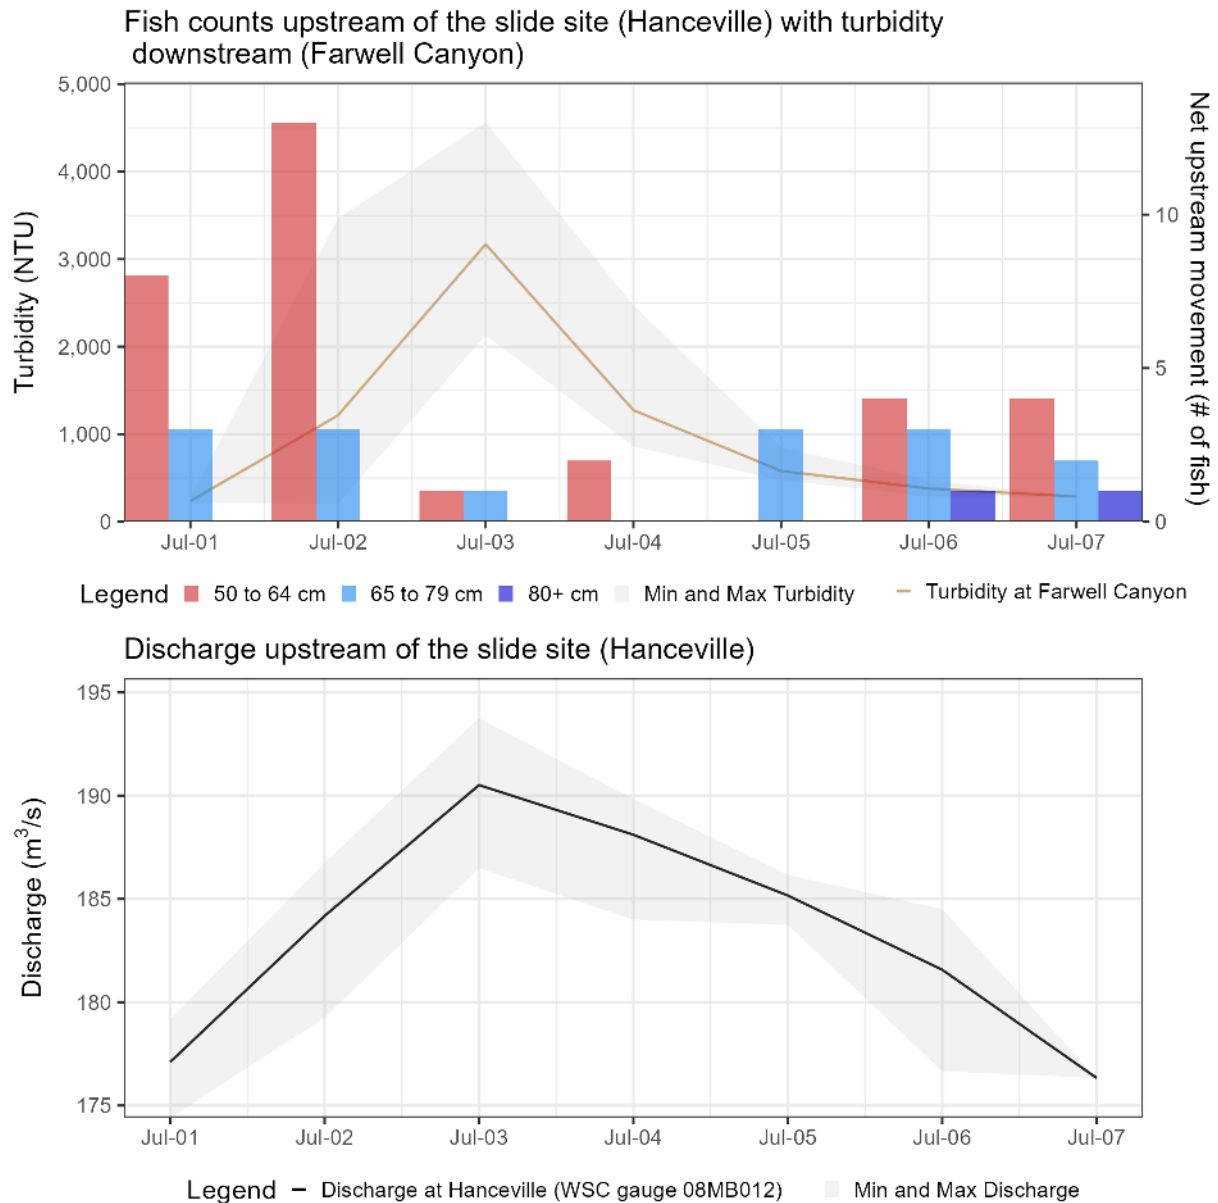
A total of 49 salmon¹ were counted during Week #2 (Figure 3) between July 01 to 07 2025. This includes 2 presumed Chinook salmon (>80 cm in length), that were observed from 2025-07-06 to 2025-07-07, as well as 32 presumed Sockeye Salmon (50 to 64 cm in length) and 15 mixed salmon” (65 to 79 cm in length). Presumed Sockeye Salmon observations occurred from 2025-07-01 to 2025-07-07 and peak counts occurred on 2025-07-02 (n = 13). The 15 mixed salmon” (fish of intermediate size to Sockeye and Chinook) were observed from 2025-07-01 to 2025-07-07.

Figure 3. Net daily movement of salmon² past the Hanceville sonar upstream of the slide site (20 minute count per hour – data not expanded), with turbidity measured downstream of the slide site (Farwell Canyon) and discharge upstream of the slide site (Hanceville) from July 01 to July 07, 2025.

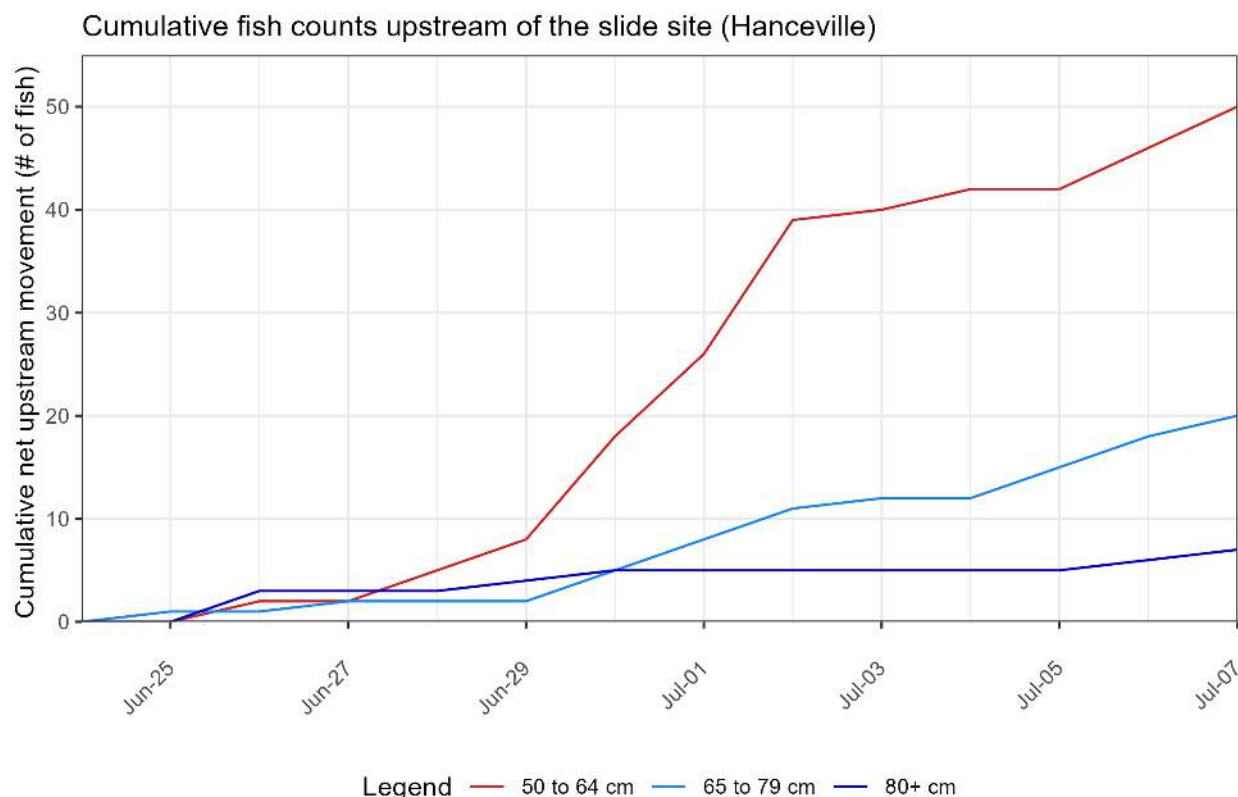
Since sonar enumeration commenced on June 24, 2025, a total of 50 presumed Sockeye Salmon, 7 presumed Chinook Salmon and 20 “mixed salmon” (between 65 and 79 cm in length) have been counted moving upstream past the sonar station at Hanceville (Figure 4).

Figure 4 Cumulative daily counts of salmon³ movement (20 minute count per hour –data not expanded) past the Hanceville sonar upstream of the slide site from June 24, 2025 to July 07, 2025.

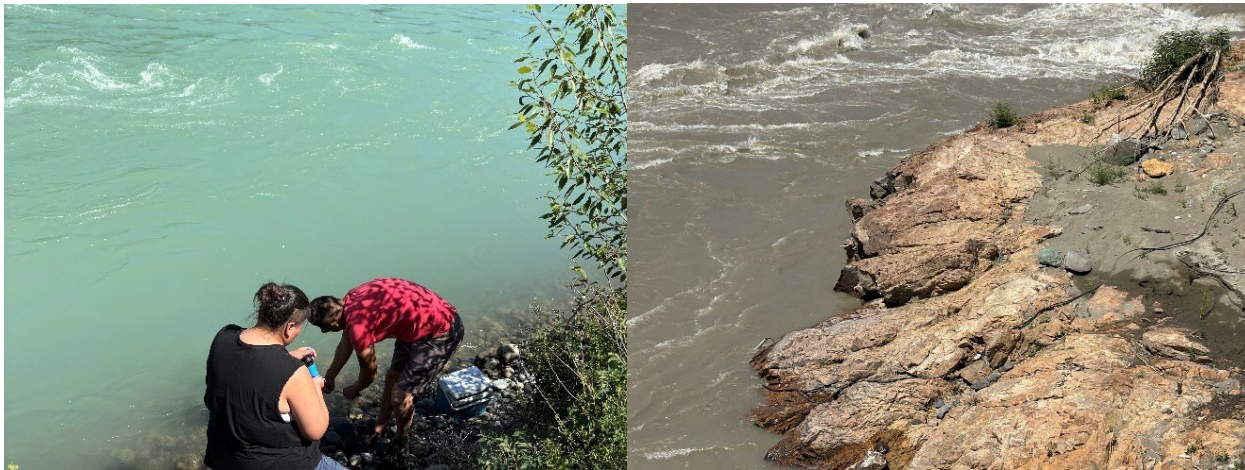
Figure 5 Water quality conditions upstream of the slide impact area (left, Hanceville) and downstream of the slide impact area (right, Farwell Canyon) captured on July 01, 2025.

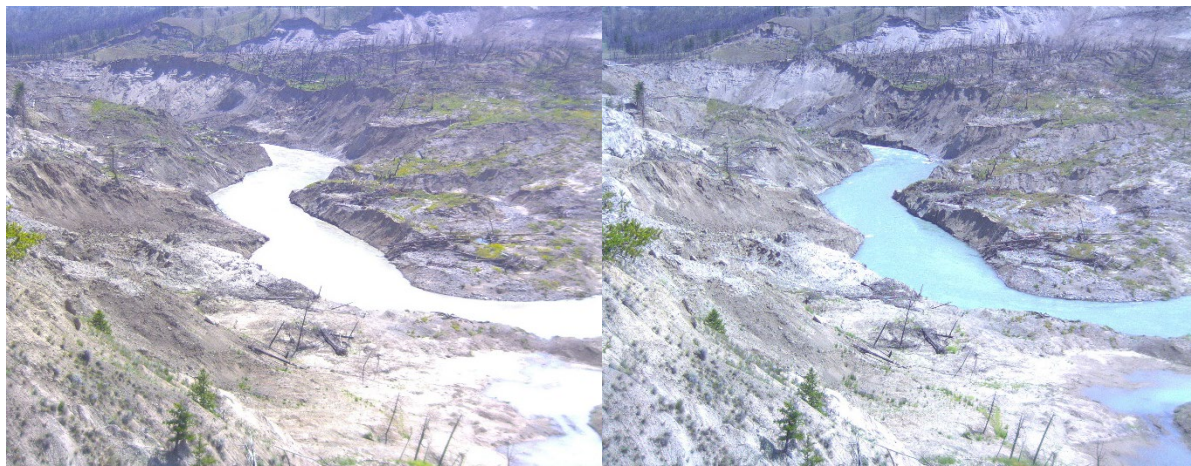
The camera station was not operational between June 11 to July 03, 2025. On July 04, the camera was operating and captured a new photo (Figure 7). The figure below shows the difference between June 10 and July 04, indicating a slope failure within this time period. Further discussions with the Task Force and ongoing monitoring indicated this event likely occurred around July 02, 2025. During this same period, a sloughing event occurred along the right bank of the landslide deposit, and increases in turbidity were observed, as highlighted in Sections 3.1 and 3.2.

Figure 7 Recent bank movement at the landslide area. Photo on the left captured June 10, 2025 and photo on the right captured July 04, 2025.

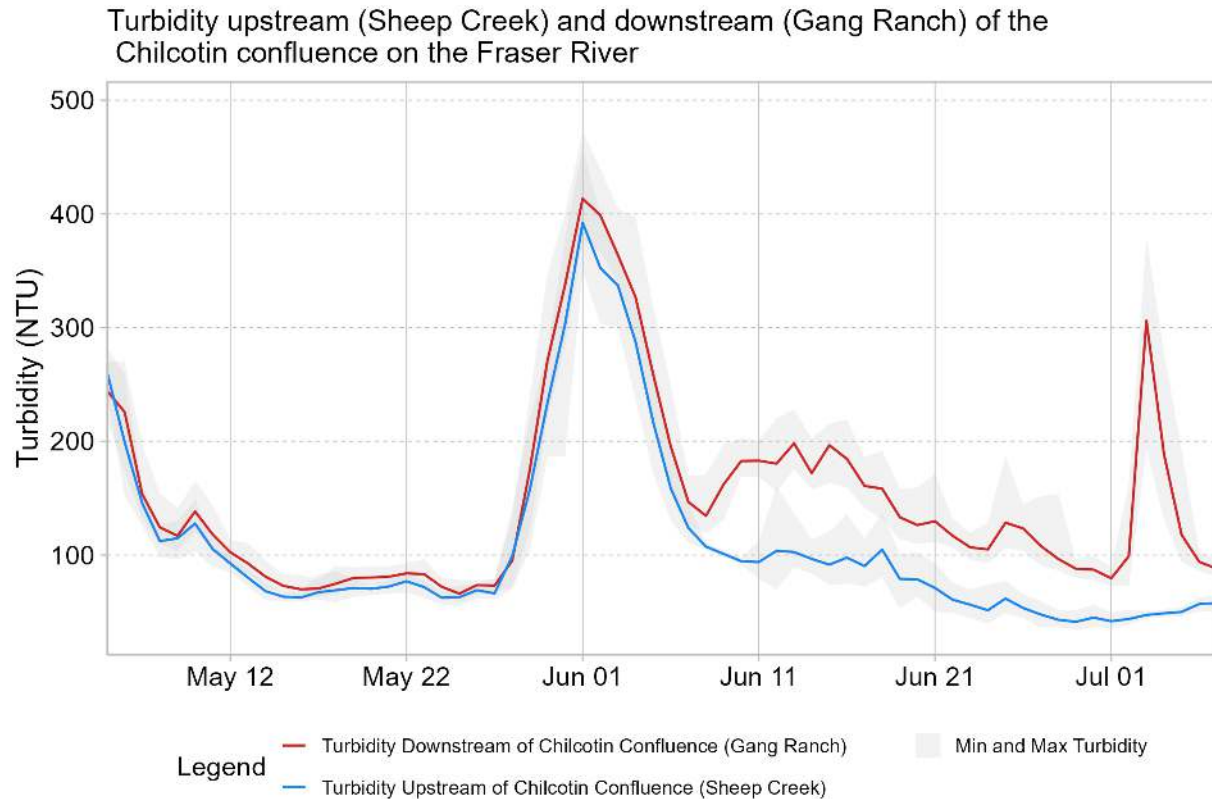
In the Fraser River, discharge ranged from 2030 m³/s to 2252 m³/s (mean = 2188 m³/s) Upstream of the Chilcotin-Fraser confluence (Sheep Creek) turbidity ranged from 36 NTU to 65 NTU, with an overall mean of 49 NTU. Turbidity downstream of the confluence (Gang Ranch) ranged from 73 NTU to 379 NTU (mean = 139 NTU) (Figure 8). The differences in turbidity upstream and downstream of the confluence of the Chilcotin and Fraser River can be seen by differences in river colour in the recent satellite imagery from the junction (Figure 10).

Figure 8 Turbidity in the Fraser upstream of the Chilcotin confluence (Sheep Creek) and downstream of the confluence (Gang Ranch) from May 01, 2025 to July 08, 2025.

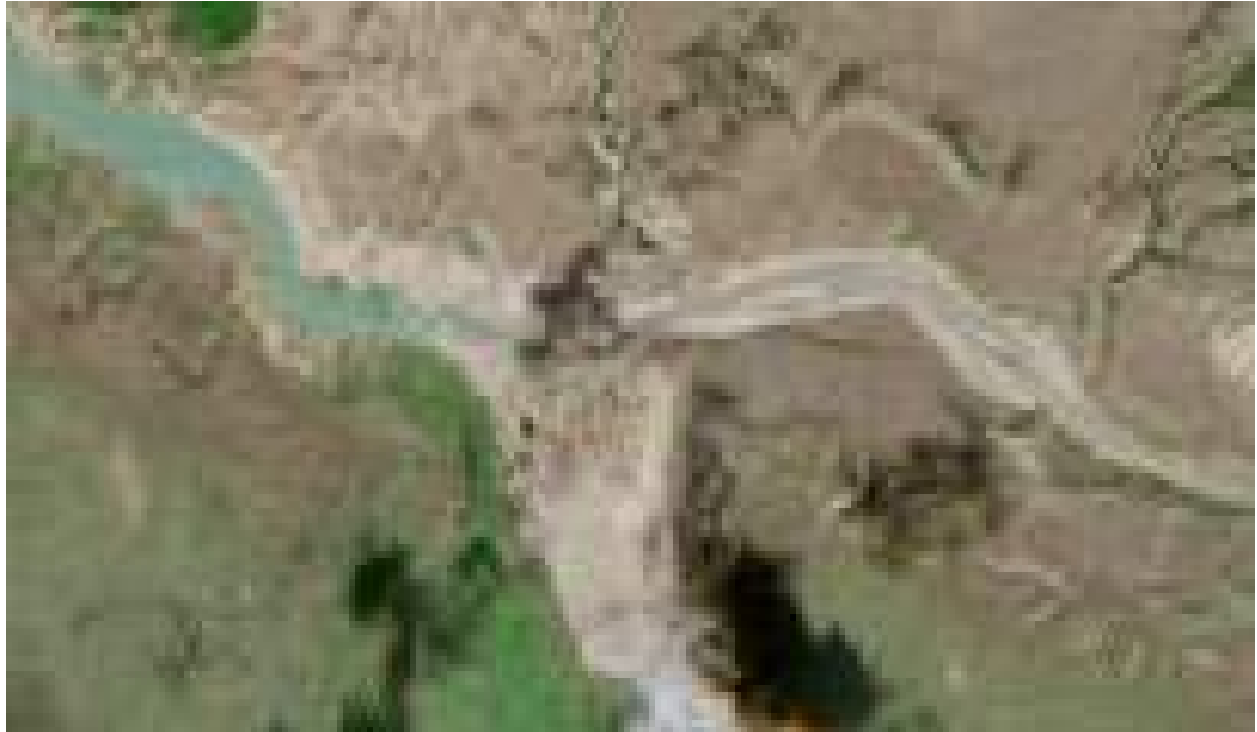
Figure 9 Satellite image of Chilcotin River upstream (left) and downstream (right) of the Farwell Canyon slide site on July 03, 2025 (Copernicus 2025).

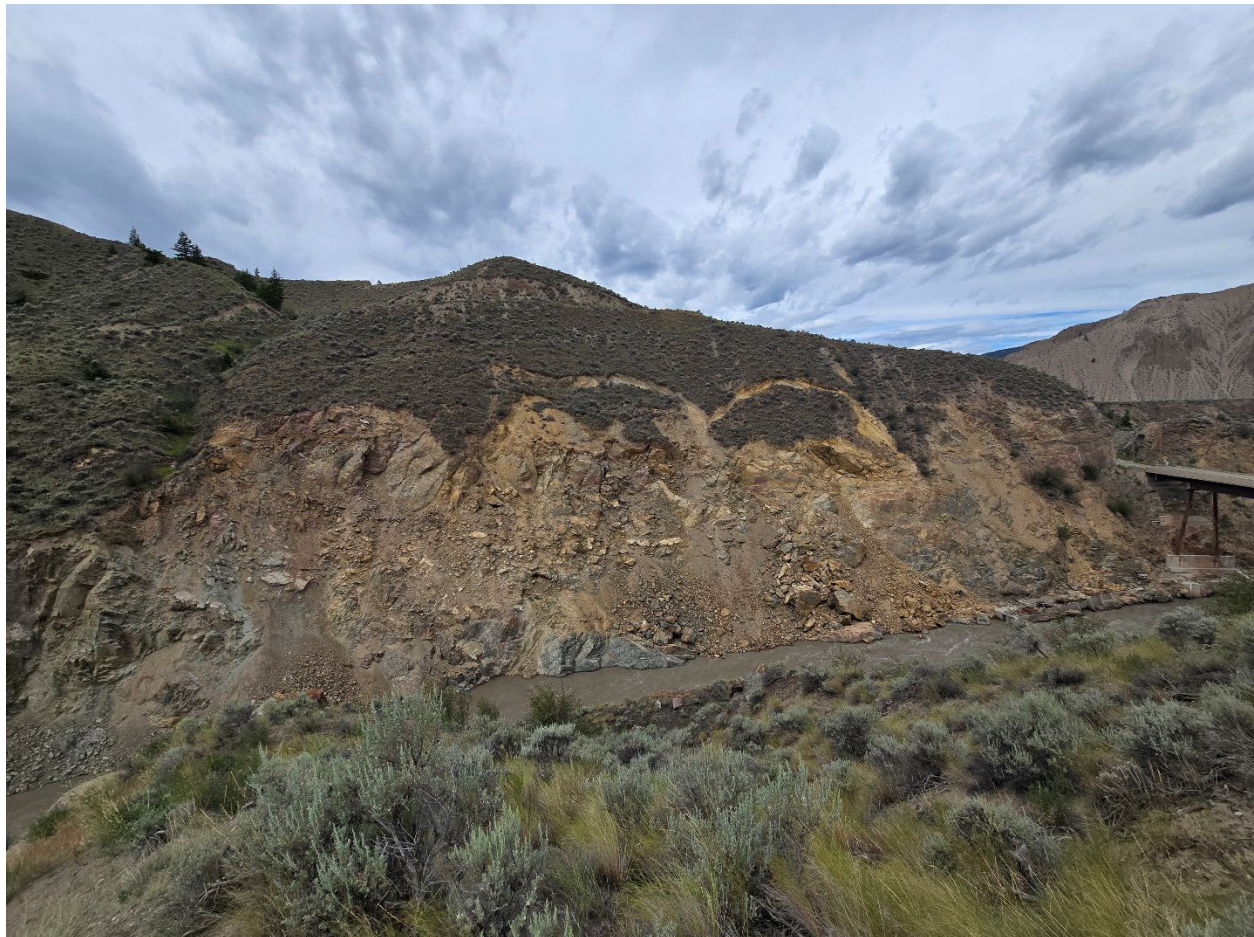
- No significant change to the rock slope was noted in the field since the previous visit (June 25, 2025)
- High river flows with a lot of sediment have been noted since June 13, 2025.
- An overview photo (Figure 11) of the site is attached from July 02, 2025.

Figure 11 Overview photo of the Farwell Canyon slope tension crack that resulted from 2024 breakout flood, taken on July 02, 2025.
