TNG-led Emergency Salmon Task Force Weekly Data Report July 15 – 21 2025

1. INTRODUCTION

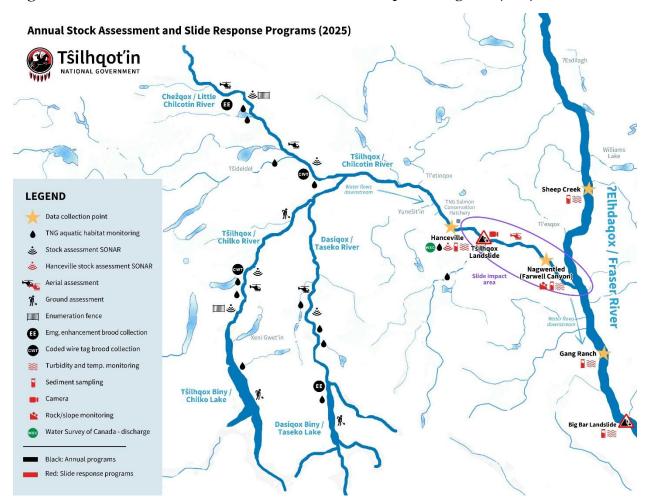
Figure 1 TNG Annual Stock Assessment and Slide Response Programs (2025).

The following weekly report prepared by TNG with support from Ecofish, summarizes 2025 monitoring data for fish passage and environmental conditions (river conditions update) from May 1 to July 21, 2025 (start date varies with program). This summary includes:

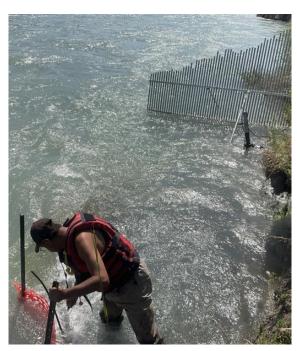
Figure 2. Diversion fence maintenance at the right bank Hanceville Bridge sonar site on July 16, 2025.

Due to high flows and large amounts of transported debris, the river-left fence was repositioned further up the bank and additional supports were added. No flow-related issues occurred at the river-right sonar site where the upstream diversion fence prevented debris strikes (Figure 2). However, the hard-drive at the river-right site malfunctioned on July 20, 2025, resulting in a 12-hour data outage. The drive was replaced on July 21, 2025, and the station is now functioning normally.

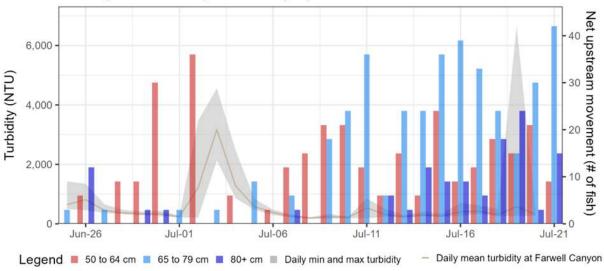
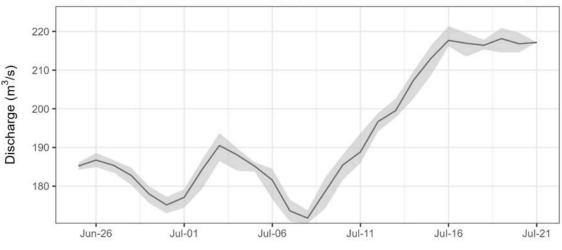
Figure 3. Expanded¹ net daily movement of salmon² past the Hanceville sonar upstream of the slide site, with turbidity measured downstream of the slide site (Farwell Canyon) and discharge upstream of the slide site (Hanceville) from June 25 to July 21, 2025.

Fish counts upstream of the slide site (Hanceville) with daily mean, min and max turbidity downstream (Farwell Canyon)

Daily mean, min and max discharge upstream of the slide site (Hanceville)

Daily salmon passage with turbidity and discharge is presented in Figure 3, noting that Olson *et al.* (2024) estimate that salmon passing downstream of the slide site (Farwell Canyon) arrive at the sonar station upstream of the slide site (Hanceville) roughly one to three days later.

For sonar data, twenty minutes of every hour have been counted and data have been expanded to the full hour. Infilling of data will occur during post-season analysis. A total of 411 salmon were counted during Week #4 (Figure 3). This includes 84 presumed Chinook Salmon (>80 cm in length), that were observed from July 15 to July 21 with peak counts (n = 24) occurring on July 19, as well as 108 salmon between 50 to 64 cm in length and 219 salmon between 65 to 79 cm in length. Observations of salmon between 50 to 64 cm in length occurred from July 15 to July 21 and peak counts occurred on July 15 (n = 24). Salmon of 65 to 79 cm length were observed from July 15 to July 21, 2025. There was no detectable disruption of salmon migration upstream of the slide site following turbidity spikes on July 19 and 21, 2025, with daily total salmon counts on July 20 and 21 comparable to previous days. Given the travel time from turbidity sensor downstream of the slide site (Farwell Canyon) to the sonar station upstream of the slide site (Hanceville), it is possible that a disruption in salmon passage has not yet been detected at the sonar station.

¹ One twenty-minute file was reviewed per hour of sonar operation (as per DFO standards). To estimate total fish passage per hour, the twenty-minute counts were expanded by a factor of three to expand to the full hour. Infilling will be completed in post-season analysis.

² Mixed salmon separated by size (50 to 64 cm) and (65 to 79 cm), and presumed Chinook (80+ cm), as defined by the Department of Fisheries and Oceans (DFO).

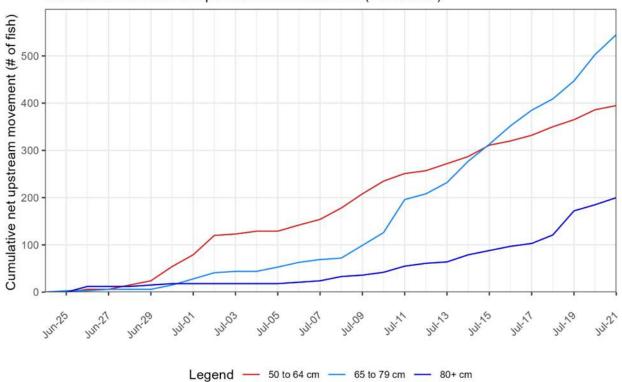
Figure 4. Expanded³ cumulative daily counts of salmon⁴ movement past the Hanceville sonar upstream of the slide site from June 24, 2025 to July 21, 2025.

Cumulative fish counts upstream of the slide site (Hanceville)

Since sonar enumeration commenced on June 25, 2025, a total of 200 salmon > 80 cm, 545 salmon between 65 to 79 cm in length, and 395 salmon between 50 and 64 cm in length have been counted moving upstream past the sonar station at Hanceville (Figure 4).

³ One twenty-minute file was reviewed per hour of sonar operation (as per DFO standards). To estimate total fish passage per hour, the twenty-minute counts were expanded by a factor of three to expand to the full hour. Infilling will be completed in post-season analysis.

⁴ Mixed salmon separated by size (50 to 64 cm) and (65 to 79 cm), and presumed Chinook (80+ cm), as defined by the Department of Fisheries and Oceans (DFO).

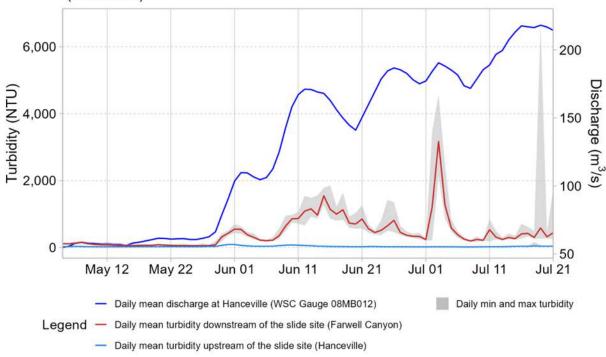
Figure 5. Turbidity and discharge measured in the Chilcotin River upstream of the slide site (Hanceville) and turbidity measured downstream of the slide site (Farwell Canyon) from May 01, 2025, to July 21, 2025.

Daily mean, min and max turbidity in the Chilcotin River upstream (Hanceville) and downstream (Farwell Canyon) of landslide area with daily mean discharge (Hanceville)

During the week of July 15 to July 21, discharge in the Chilcotin River upstream of the slide site (Hanceville) ranged from 206 m³/s to 218 m³/s (mean = 216 m³/s) (Figure 5). Turbidity ranged from 28 NTU to 168 NTU at Hanceville, with an overall mean of 38 NTU. Downstream of the slide site (Farwell Canyon) turbidity was higher, ranging from 230 NTU to 6,647 NTU, with an overall mean of 391 NTU. Three turbidity spikes were observed on July 19 and July 21, ranging from 1,330 to 6,647 NTU for a short duration of 3-12 hrs, compared to baseline downstream turbidity, averaging 300 NTU. The 6,647 NTU maximum spike in turbidity observed this week downstream of the slide site (Farwell Canyon) occurred on July 19, for a duration of 5 hrs. The differences in turbidity upstream and downstream of the Farwell Canyon slide site can be seen by differences in river colour in recent field photos (Figure 6) and recent satellite imagery (Figure 7). Field crews in the area observed heavy localized rainfall events this week.

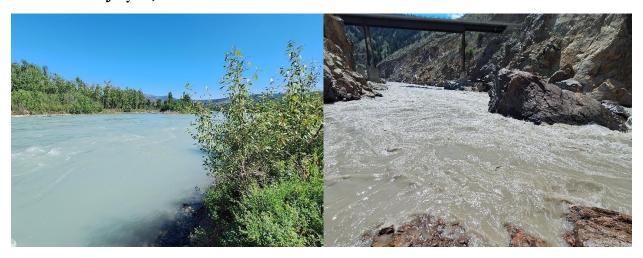
Figure 6. Water quality conditions upstream of the slide impact area (left, Hanceville) and downstream of the slide impact area (right, Farwell Canyon) captured on July 16, 2025.

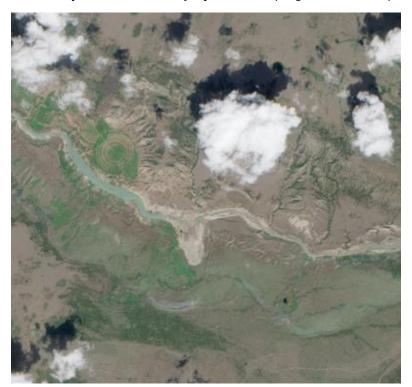
Figure 7. Satellite image of Chilcotin River upstream (left) and downstream (right) of the Farwell Canyon slide site on July 18, 2025 (Copernicus 2025).

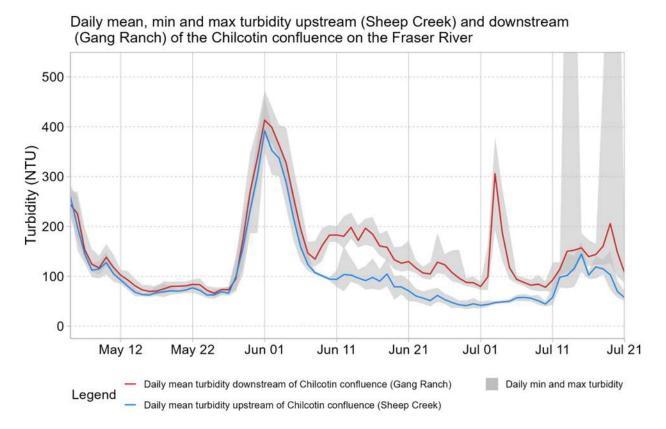
Figure 8. Turbidity in the Fraser upstream of the Chilcotin confluence (Sheep Creek) and downstream of the confluence (Gang Ranch) from May 01, 2025 to July 21, 2025.

During the week of July 15 to July 21, turbidity upstream of the Chilcotin-Fraser confluence (Sheep Creek) ranged from 51 NTU to 169 NTU, with an overall mean of 102 NTU (Figure 8). Turbidity downstream of the confluence (Gang Ranch) ranged from 87 NTU to a maximum of 1,004 NTU on July 20 (mean = 152 NTU). Three turbidity spikes were observed downstream of the confluence (Gang Ranch) between July 19 and July 21, ranging from 380-1,004 NTU for a short duration of 5-12 hrs, compared to baseline downstream turbidity, averaging 100 NTU. The differences in turbidity upstream and downstream of the confluence of the Chilcotin and Fraser rivers can be seen by differences in river colour in the recent satellite imagery from the junction (Figure 9).

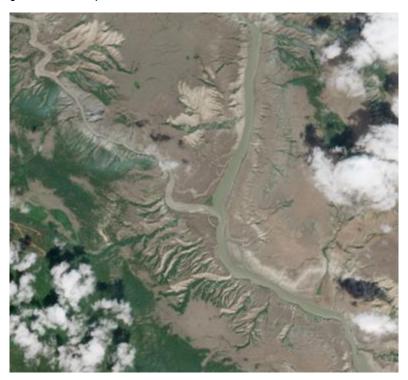
Figure 9. Satellite image of the Chilcotin River at confluence with Fraser River on July 18, 2025 (Copernicus 2025).
