TNG-led Emergency Salmon Task Force Weekly Data Report July 08 – 14 2025

The following weekly report prepared by TNG with support from Ecofish, summarizes 2025 monitoring data for fish passage and environmental conditions (river conditions update) from May 1 to July 14, 2025 (start date varies with program). This summary includes:

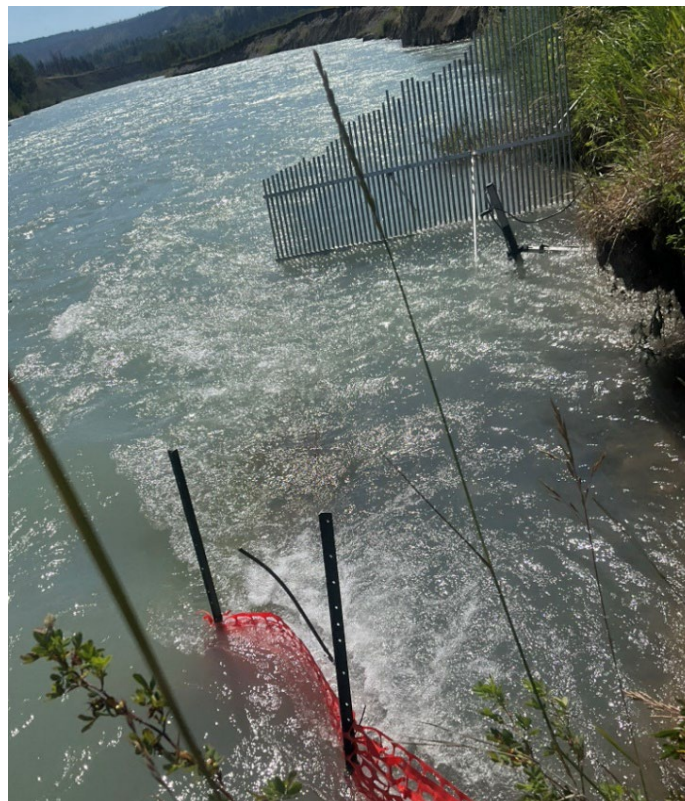
Figure 2. Looking downstream at the right bank Hanceville Bridge sonar site on July 14, 2025.

There have been minor planned sonar outages on river left bank for routine maintenance activities, while on river-right the sonar has been pushed out of orientation twice by high flows and debris, resulting in outages. A small diversion fence was installed upstream on July 14 to shelter the unit (Figure 2), which has been effective to date to mitigate outages. With more rain in the forecast later in the week, the crew has staged materials to fence the river-left side-channel to ensure all fish pass within the ensounded area and will continue to monitor conditions. We anticipate dip netting for species and size validation will occur in the coming days as salmon abundance increases. We will re-evaluate size bin and species relationships as more empirical data are collected.

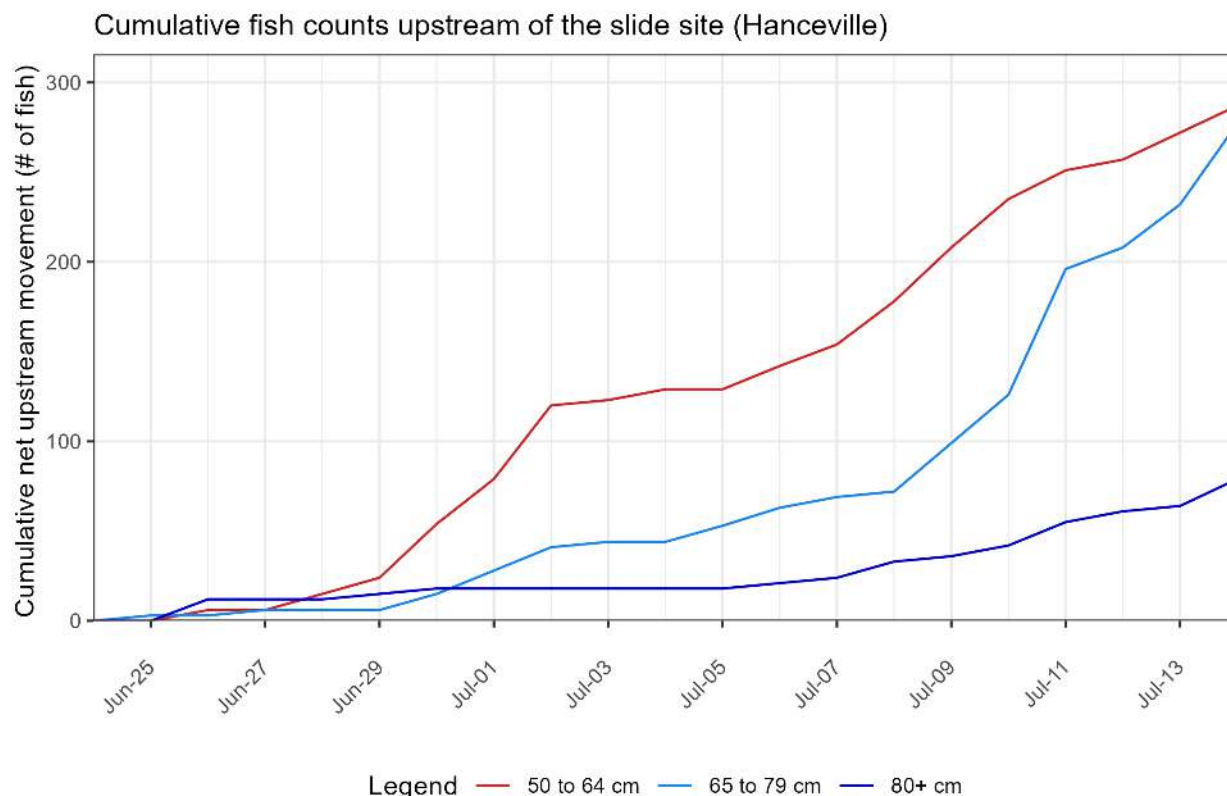
Figure 4. Expanded³ cumulative daily counts of salmon⁴ movement past the Hanceville sonar upstream of the slide site from June 24, 2025 to July 14, 2025.

³ One twenty-minute file was reviewed per hour of sonar operation (as per DFO standards). To estimate total fish passage per hour, the twenty-minute counts were expanded by a factor of three to expand to the full hour. Infilling will be completed in post-season analysis.

⁴ Mixed salmon separated by size (50 to 64 cm) and (65 to 79 cm). presumed Chinook (80+ cm), as defined by the Department of Fisheries and Oceans (DFO).

Since sonar enumeration commenced on June 25, 2025, a total of 79 salmon > 80 cm, 287 salmon 65 to 79 cm, and 277 salmon 50 to 64 cm in length, have been counted moving upstream past the sonar station at Hanceville (Figure 4).

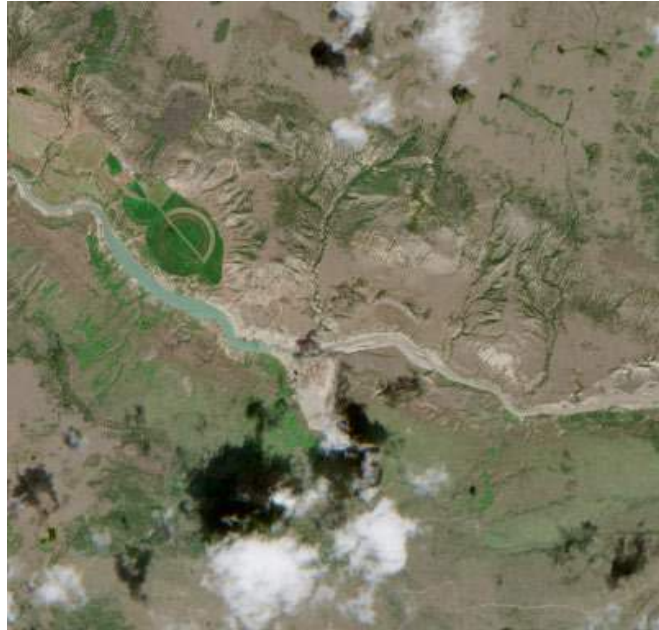
Figure 6. Satellite image of Chilcotin River upstream (left) and downstream (right) of the Farwell Canyon slide site on July 03, 2025 (Copernicus 2025). Heavy cloud cover this week did not allow for more recent imagery.

During the week of July 08 to July 15, discharge in the Chilcotin River upstream of the slide site (Hanceville) ranged from 168 m³/s to 207 m³/s (mean = 190 m³/s) (Figure 5). Turbidity ranged from 15 NTU to 37 NTU at Hanceville, with an overall mean of 22 NTU. Downstream of the slide site (Farwell Canyon) turbidity was higher, ranging from 166 NTU to 857 NTU, with an overall mean of 290. The differences in turbidity upstream and downstream of the Farwell Canyon slide site can be seen by differences in river colour recent satellite imagery (Figure 6).

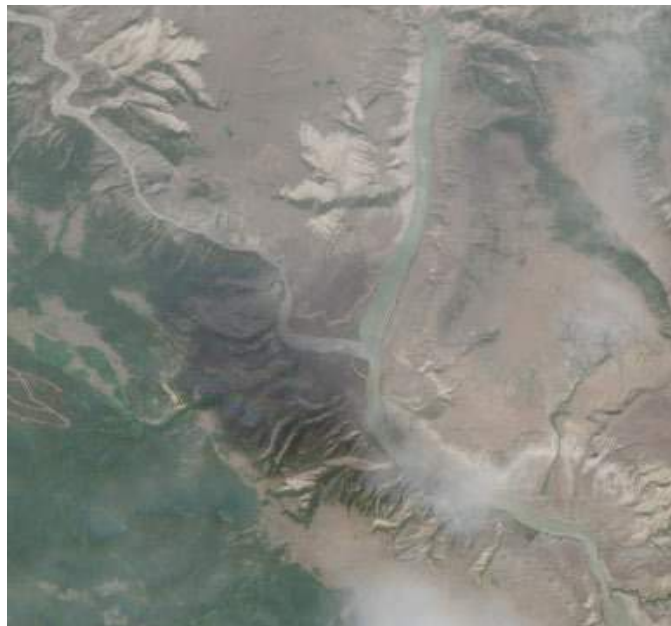
Figure 7. Satellite image of the Chilcotin River at confluence with Fraser River on July 11, 2025 (Copernicus 2025).

During the week of July 08 to July 15, upstream of the Chilcotin-Fraser confluence (Sheep Creek) turbidity ranged from 39 NTU to 333 NTU, with an overall mean of 76 NTU (Figure 8). Turbidity downstream of the confluence (Gang Ranch) ranged from 69 NTU to 956 NTU (mean = 108 NTU). The differences in turbidity upstream and downstream of the confluence of the Chilcotin and Fraser rivers can be seen by differences in river colour in the recent satellite imagery from the junction (Figure 7).

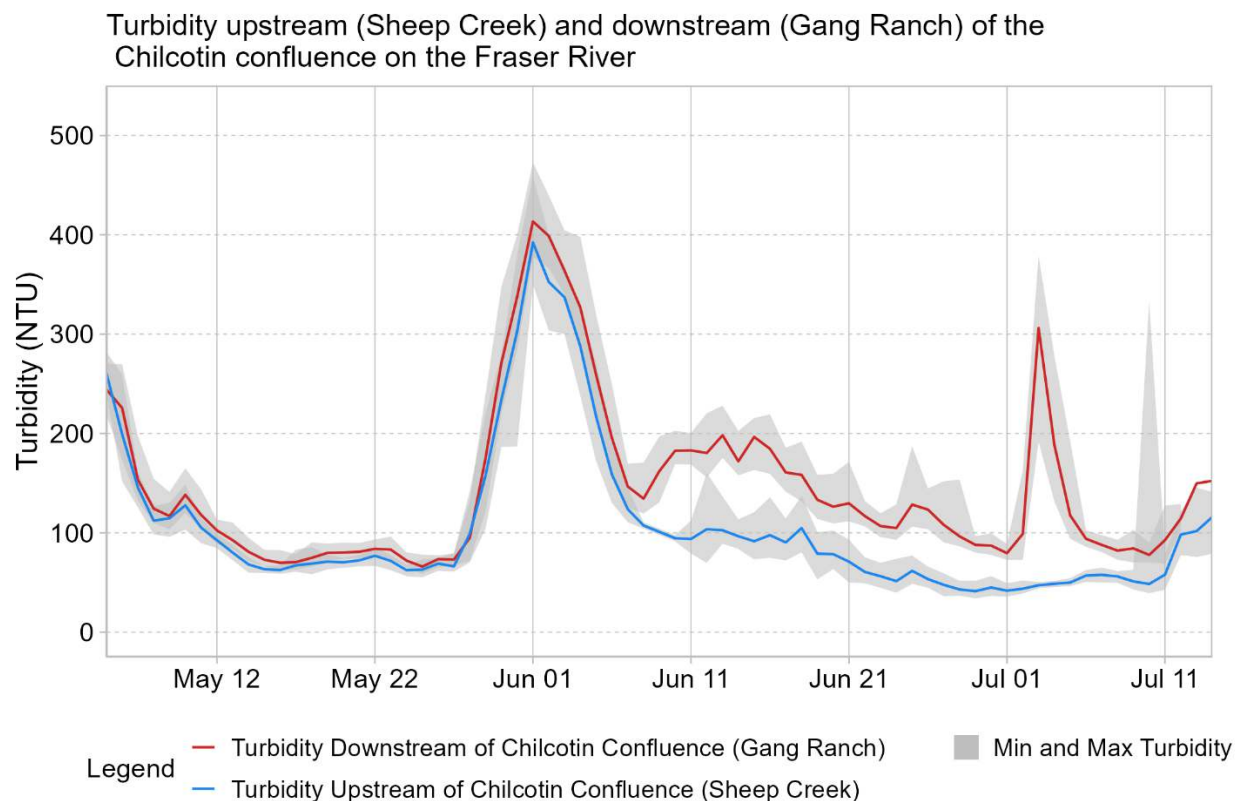
Figure 8. Turbidity in the Fraser upstream of the Chilcotin confluence (Sheep Creek) and downstream of the confluence (Gang Ranch) from May 01, 2025 to July 15, 2025.
