## **TNG-led Emergency Salmon Task Force Weekly Data Report June 16 to July 6, 2026.**

### **1. 1. INTRODUCTION**

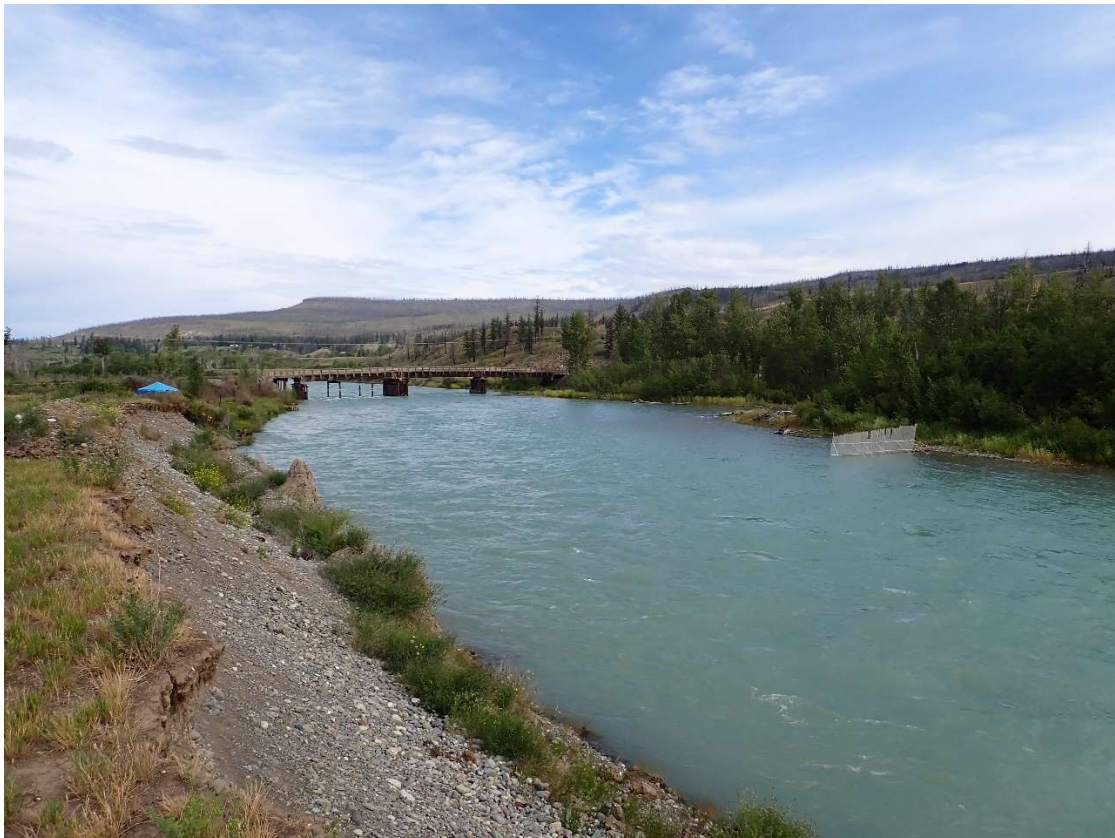
**Figure 2. Upstream view of the Hanceville sonar station. Captured on July 7, 2026.**

The river-right sonar was installed ~10 m upstream of the 2025 monitoring location. The new location was selected as it provides improved protection from high flows and safer site access. The river-left sonar and fence have been reinforced due to the presence of debris during current elevated flows.

Flood forecasts are being monitored to mitigate risk of equipment loss or damage from high stream flows during weekends. Concerns about high stream flows resulted in the removal of both river-left and right sonars on the weekend of June 27, 2026, and the removal of the river-left sonar on the weekend of July 4, 2026. Once freshet discharge recedes and the risk to equipment is deemed lower, both sonars will be left in place over weekends.

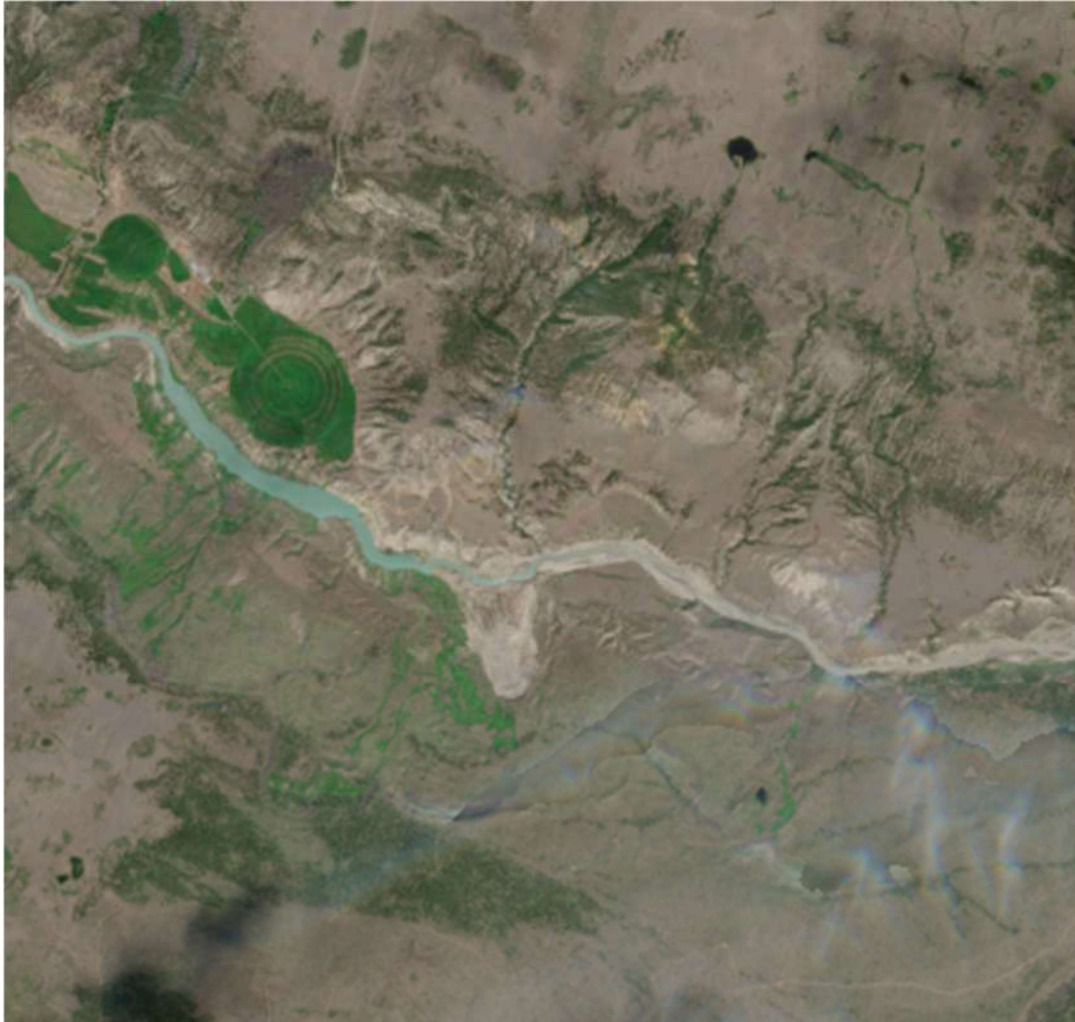
Figure 6. Satellite image of Chilcotin River upstream (left) and downstream (right) of the Tsilhqox slide site on July 6, 2026 ([Copernicus 2026](#)).

During the period of June 16 to July 6, 2026, discharge in the Chilcotin River upstream of the Tsilhqox slide site (Hanceville) ranged from 174 m<sup>3</sup>/s to 244 m<sup>3</sup>/s (mean = 230 m<sup>3</sup>/s) (Figure 5). Turbidity ranged from 28 NTU to 86 NTU at Hanceville, with an overall mean of 45 NTU. Downstream of the Tsilhqox slide site (Farwell Canyon) turbidity was higher, ranging from 87 NTU to 2,587 NTU, with an overall mean of 503 NTU. The differences in turbidity upstream and downstream of the Tsilhqox slide site can be seen by differences in river colour in recent satellite imagery (Figure 6).

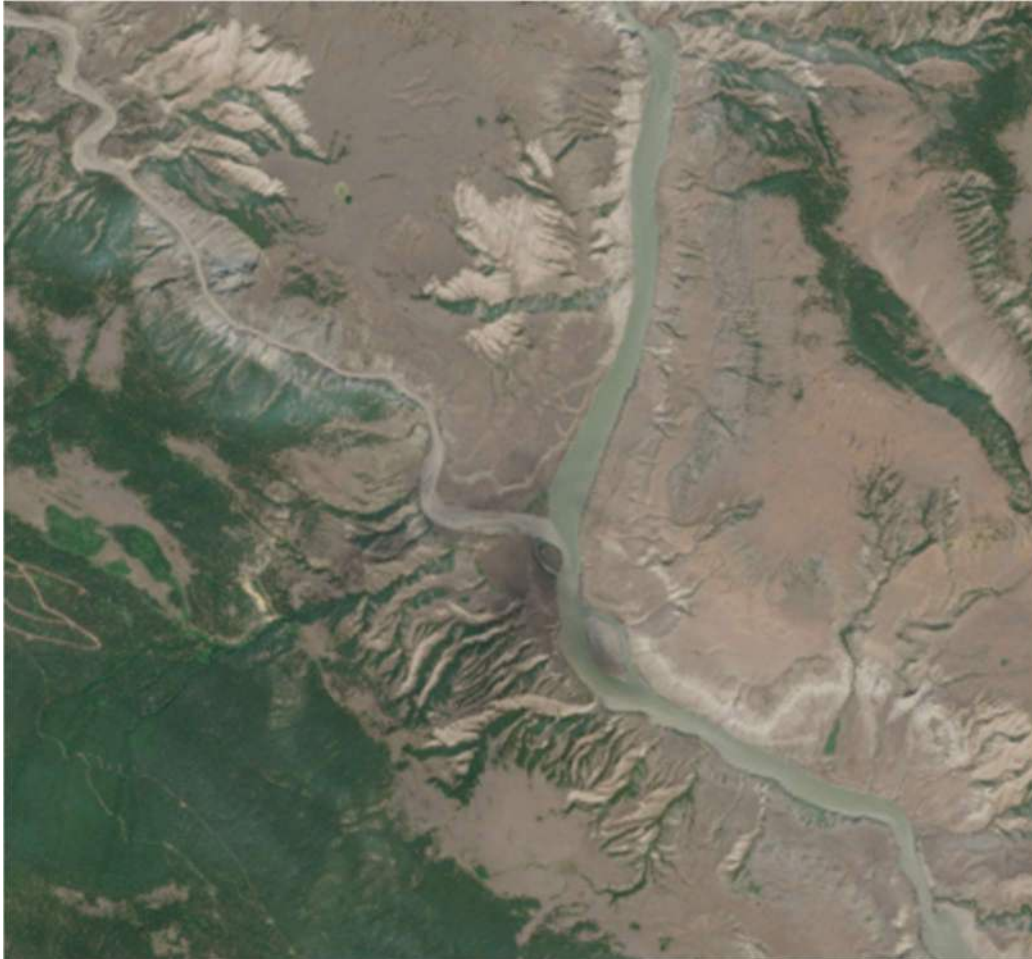
Figure 8. Satellite image of the Chilcotin River at confluence with the Fraser River on July 6, 2026 ([Copernicus 2026](#)).
